US Environmental Protection Agency  
Region 2–Caribbean Environmental Protection Division  
*Resource Conservation and Recovery Act (RCRA)*  
*Compliance Evaluation Inspection Report*

**Central Ford (Centro Camiones, INC.)**  
EPA ID Number: *PRR000022046*

Inspection Date: March 1, 2013

Project ID: CEPD-RCRA-13-0267

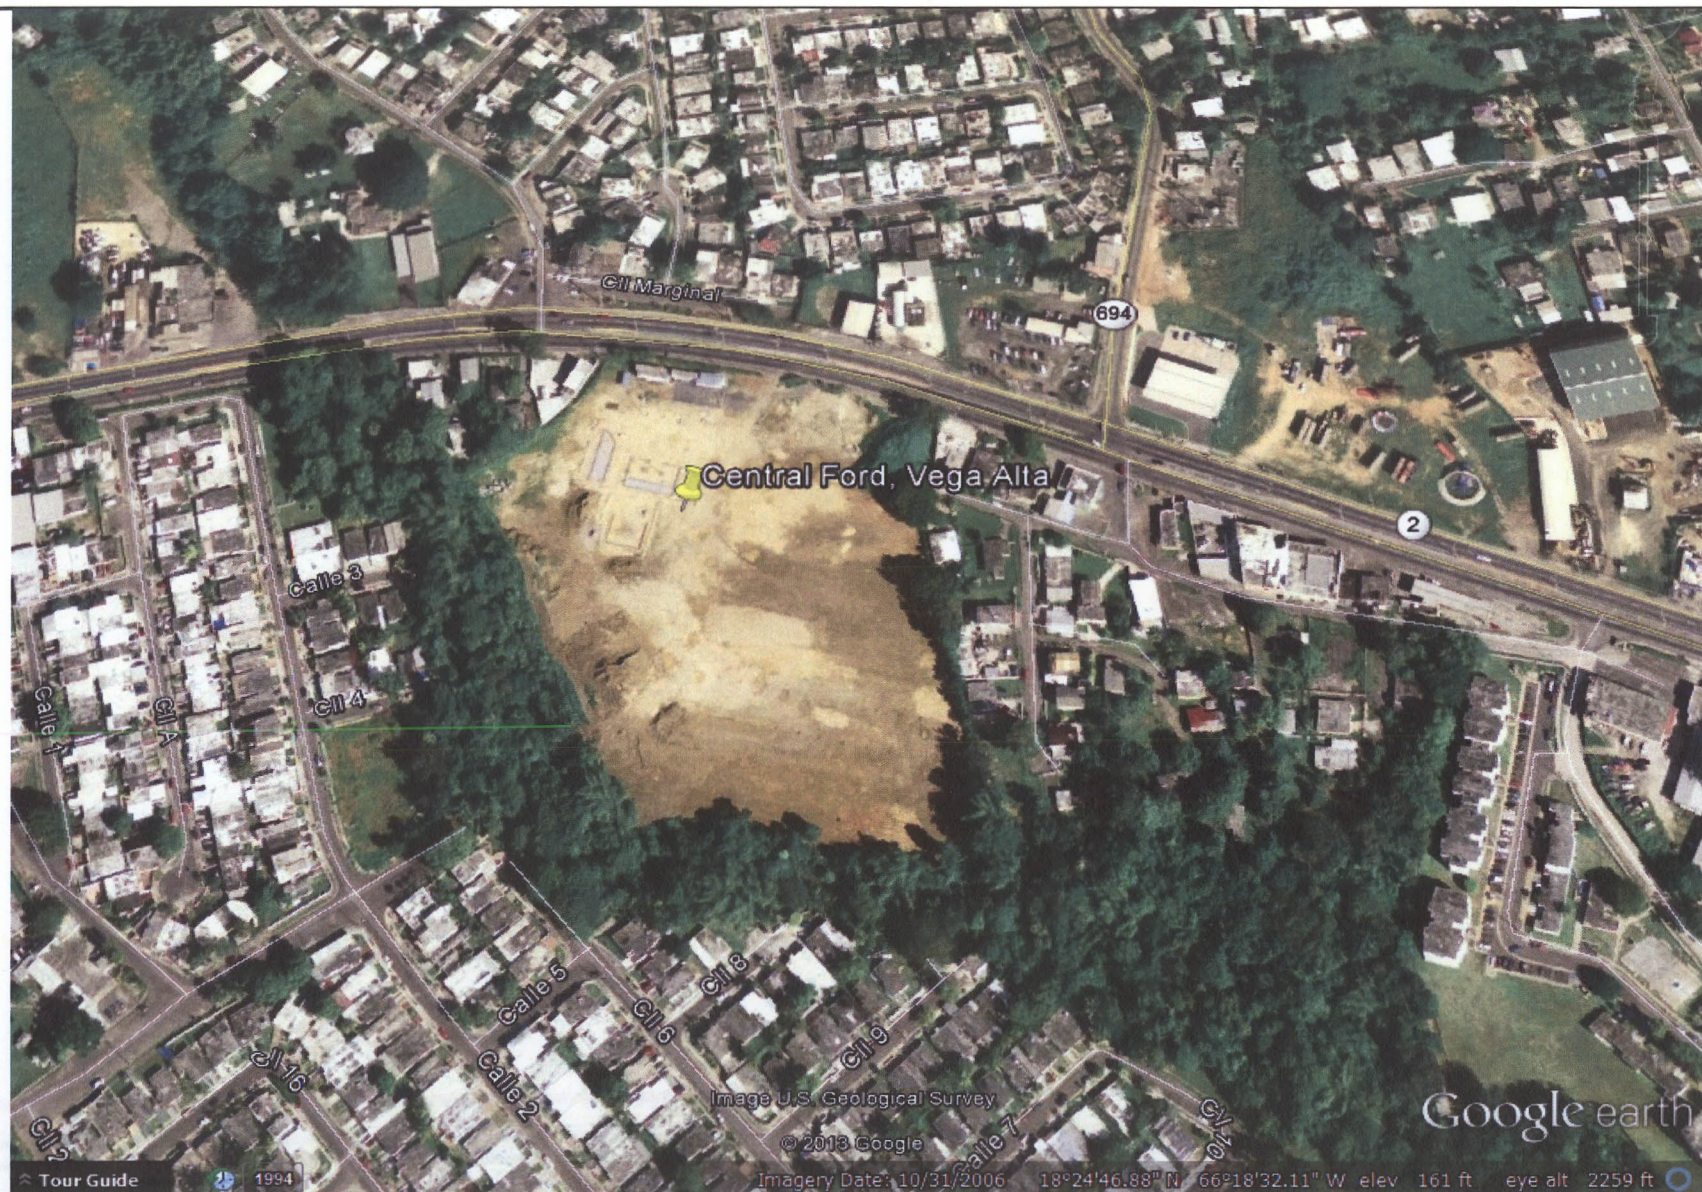
Picture 1— **“Taller Area” (Mechanic Workshop)** - An open part washer was observed inside the transmissions room.

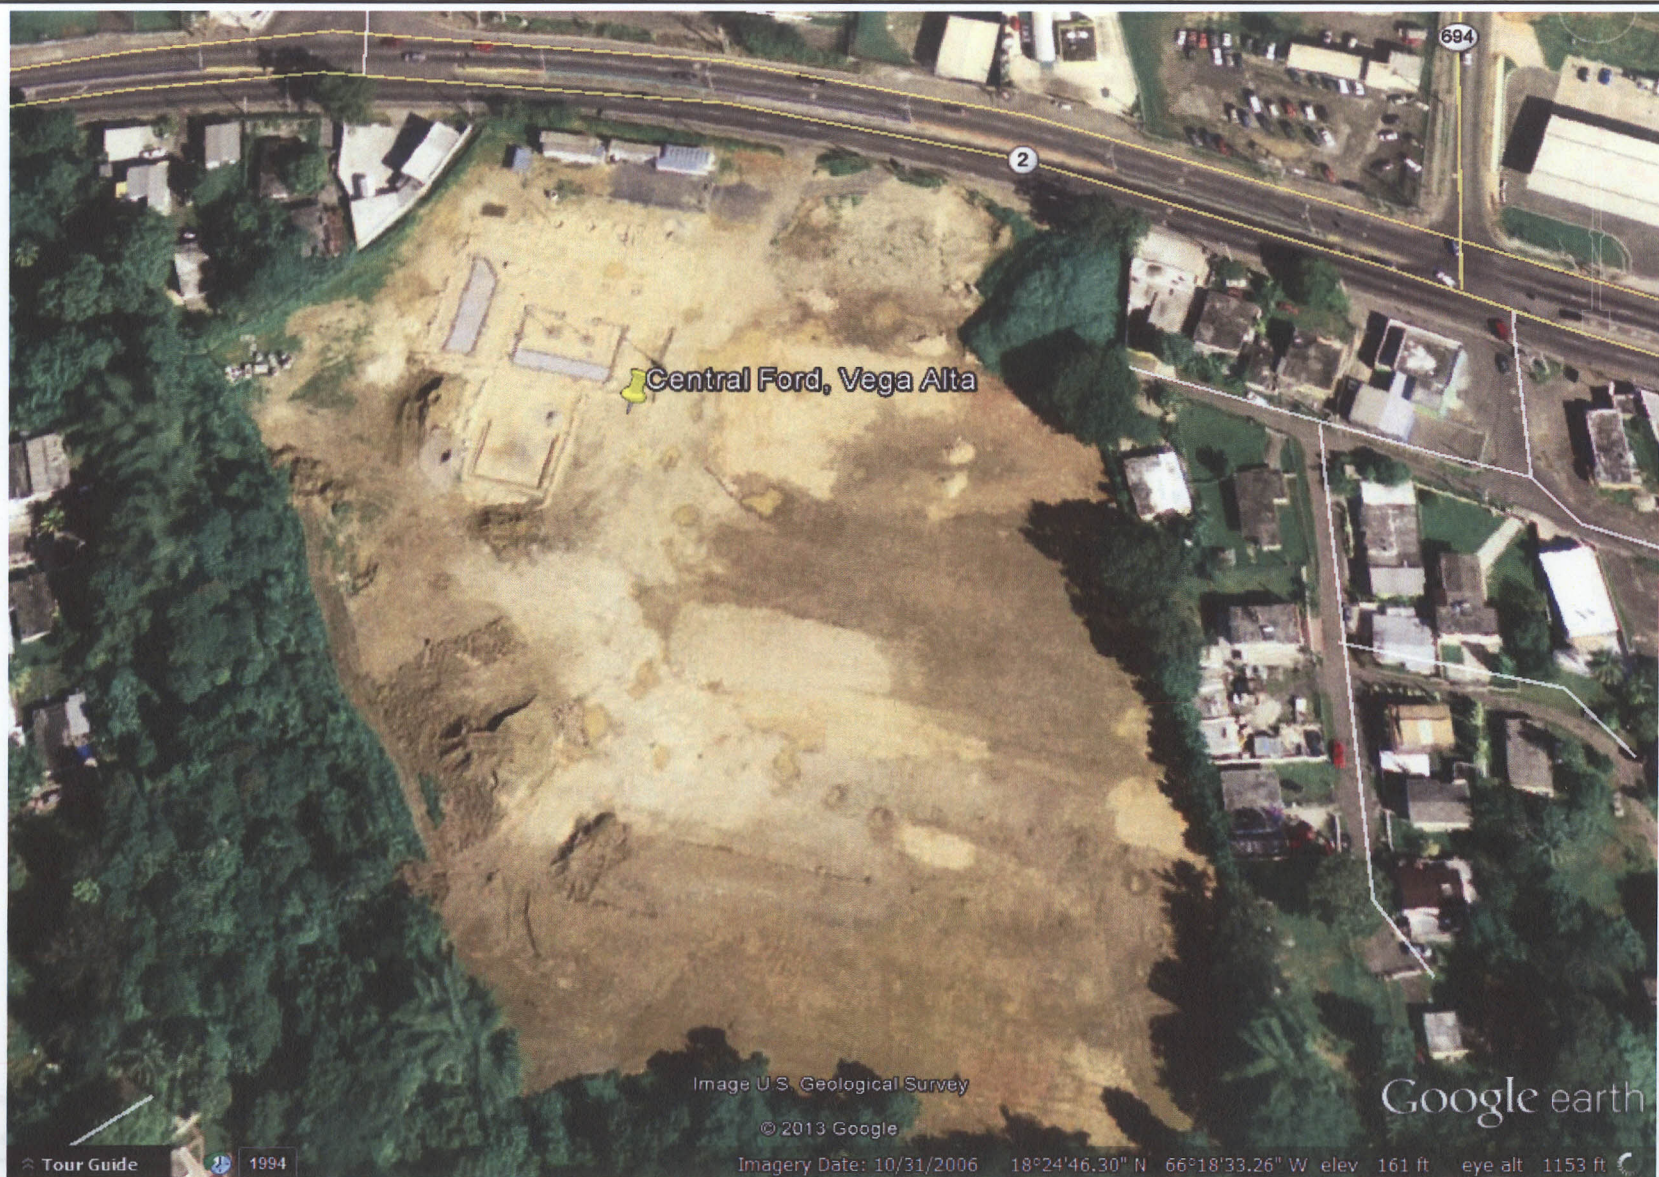
Picture 2— **“Taller Area” (Mechanic Workshop)** - Two 55-gallon drums with used filters was observed. The drum located at left side have inside approximately 20 filters. The 55-gallon drum located at right side is full.

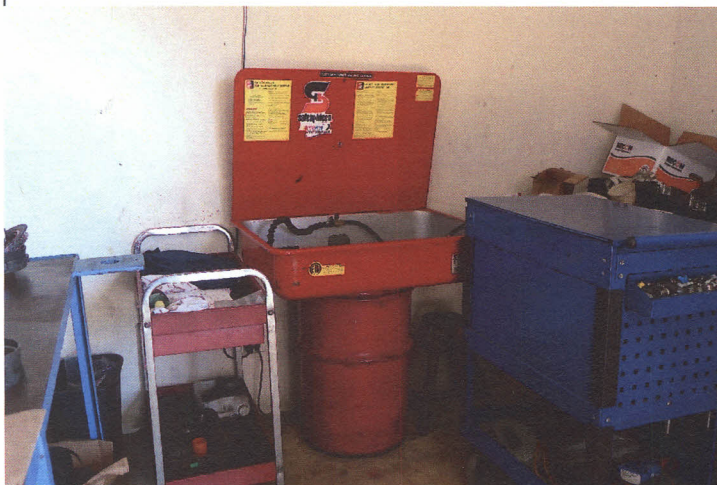
The mechanic workshop area was the first area visited during the facility tour. This is an open building that provides the mechanical maintenance and/or repair to Ford and Hyundai vehicles. At this area we observed 12 operational bays that are available to repair Ford and Hyundai vehicles. Inside the building we found a room that is known as the Transmissions Room (TR). TR is located at the left side of the building and inside we observed one part washer in use (See **Picture 1**). At the time of inspection, the part washer was open. We asked Mr. Victor Olivera, Technician, about the part washer and he told us that the company that gives services to them is

Safety Kleen and the disposal rate is approximately every three months. We advise the facility staff that the part washer needs to be close at all times. Mr. Victor Olivera then proceeded to close the part washer. Also, Mr. Victor Olivera told us that this room is used for assembling automatic transmissions.

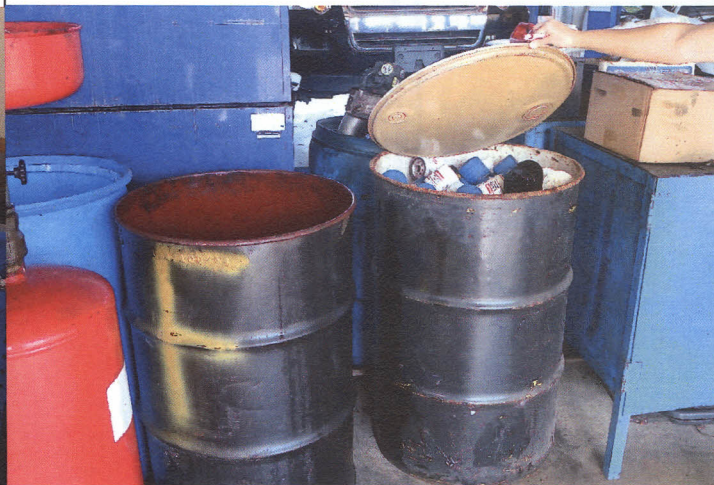
- Two 55-gallon drums with used filters (See **Picture 2**).
  - At the time of inspection one was full and the other one have approximately 20 filters. Both drums need to be labeled.
- Two part washers
  - At the time of inspection both of them were closed.
- Two 5-gallons containers with (from left to right) (See **Picture 3**)
  - No content
  - 1/3 full with gasoline for disposal. Both containers need to be labeled.
- One 55-gallons drum with rags with used oil
  - The drum was full and needs to be labeled.
- Approximately 7 16-oz containers (Refreshments containers as Coca Cola and Coco Rico) with coolants and "unknowns" inside (See **Picture 3**).
  - The containers did not have a label.
- Various batteries were observed thru the area.
  - Facility staff will identify a place to store the batteries and will identify them with the phrase: "Universal Waste".

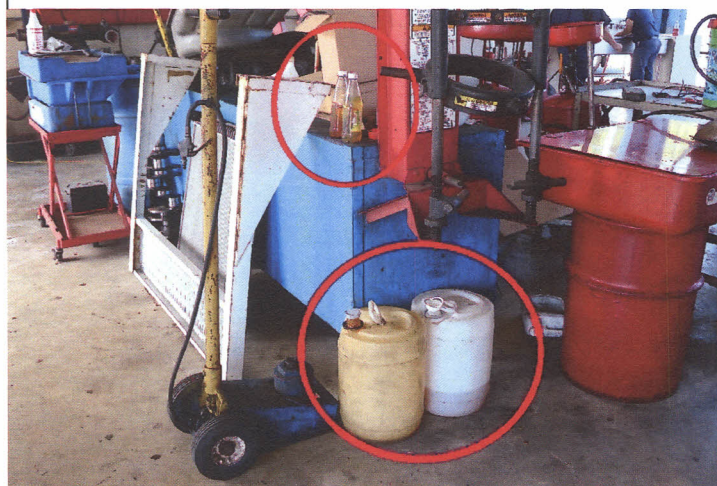
At the time of inspection CFVA have approximately 7 16-oz containers (Refreshments containers as Coca Cola and Coco Rico) with coolants, gasoline and "unknowns" inside.

Picture 3— **“Taller Area” (Mechanic Workshop)** - Two 5-gallons containers were observed. The one located at left side is empty and the one located at right side is 1/3 full with gasoline. Also, two of the seven 16 oz containers with "unknown" were observed.

CFVA failed to comply with this requirement. According with §261.5 (g)(1) "... *the generator must comply with the following requirement: Section §262.11 of this chapter*". Section §262.11 states that: "*a person who generates a solid waste ... must determine if that waste is hazardous*"

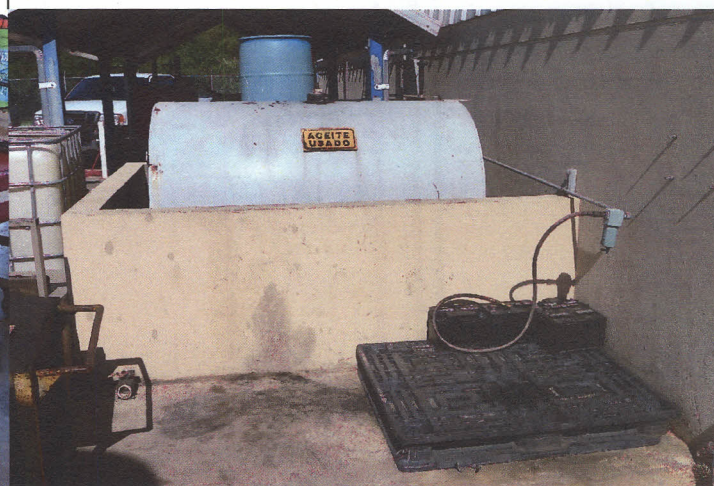
This area is located alongside the "Taller" Area. A 250-gallons tank was observed. The tank has a dike and have label (See **Photo #4**). The dike is not clean; dust and rags were observed. We advised the facility staff that they need to clean the dike and need to remove the rags observed inside. CFVA staff told us that they will clean the dike. Also, just in front of the dike a plastic pallet with various batteries was observed (See **Picture 4**). Facility staff told us that they will store all the batteries segregated thru the facility in this place and they will identify the area with the phrase: "Universal Waste". The area rendered no concerns.

Picture 4— **Outside “Taller” Area**— A 250-gallons tank was observed. The tank has a dike and has its label . Also, just in front of the dike a plastic pallet with various batteries was observed. Facility staff has identified this place to store their batteries and will label the area with the words “Universal Waste”.
